**FEDERAL AVIATION ADMINISTRATION  
AIRWORTHINESS DIRECTIVES  
SMALL AIRCRAFT, ROTORCRAFT, GLIDERS,  
BALLOONS, & AIRSHIPS**

**BIWEEKLY 2000-14**

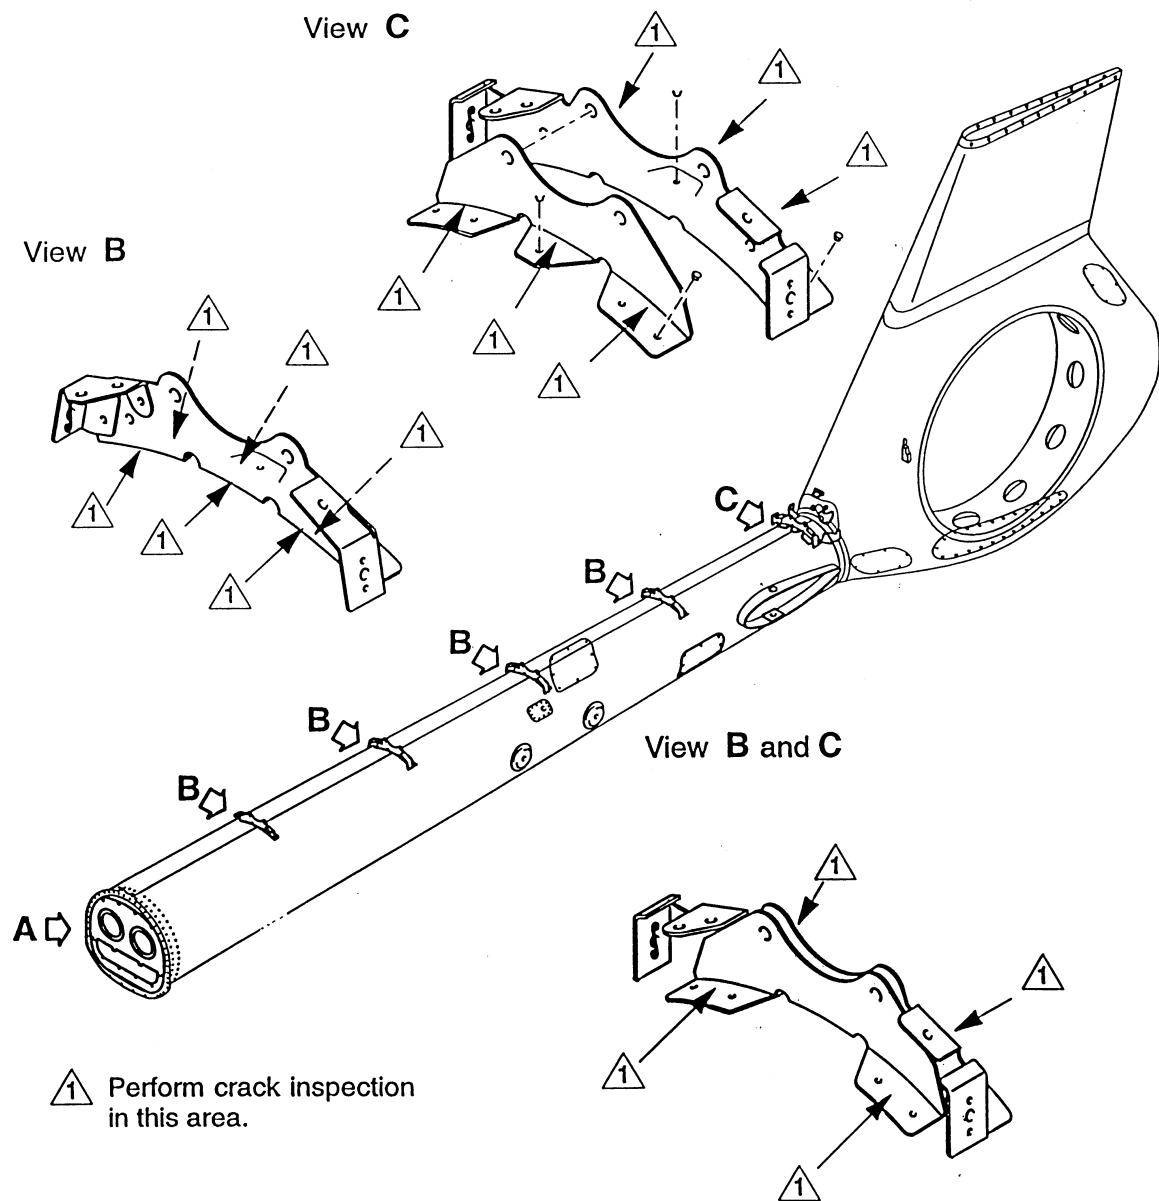
**Figure 1**

(1) Clean each tail rotor drive shaft bearing support. Using a 6-power or higher magnifying glass and a bright light, visually inspect the attach lugs of the bearing supports B and C (shown in Figure 1) for cracks, particularly in the area extending from the bend radius to the attaching screws and rivets connecting the bearing supports to the tail boom. Before further flight, replace each cracked bearing support with an airworthy bearing support.

(2) Inspect each bearing attach hardware lock plate for bent-open tabs and slippage marks for attach hardware looseness or rotation. Before further flight, replace any loose bearing attach hardware (including lock plates found bent or open due to bolt rotation) with airworthy hardware.
